## **2019 ANNUAL INSPECTION REPORT**

### **W.H. Sammis Coal Plant North Pond Stratton, Ohio**

January 2020

**CCR Unit:** W. H. Sammis North CCR Impoundment

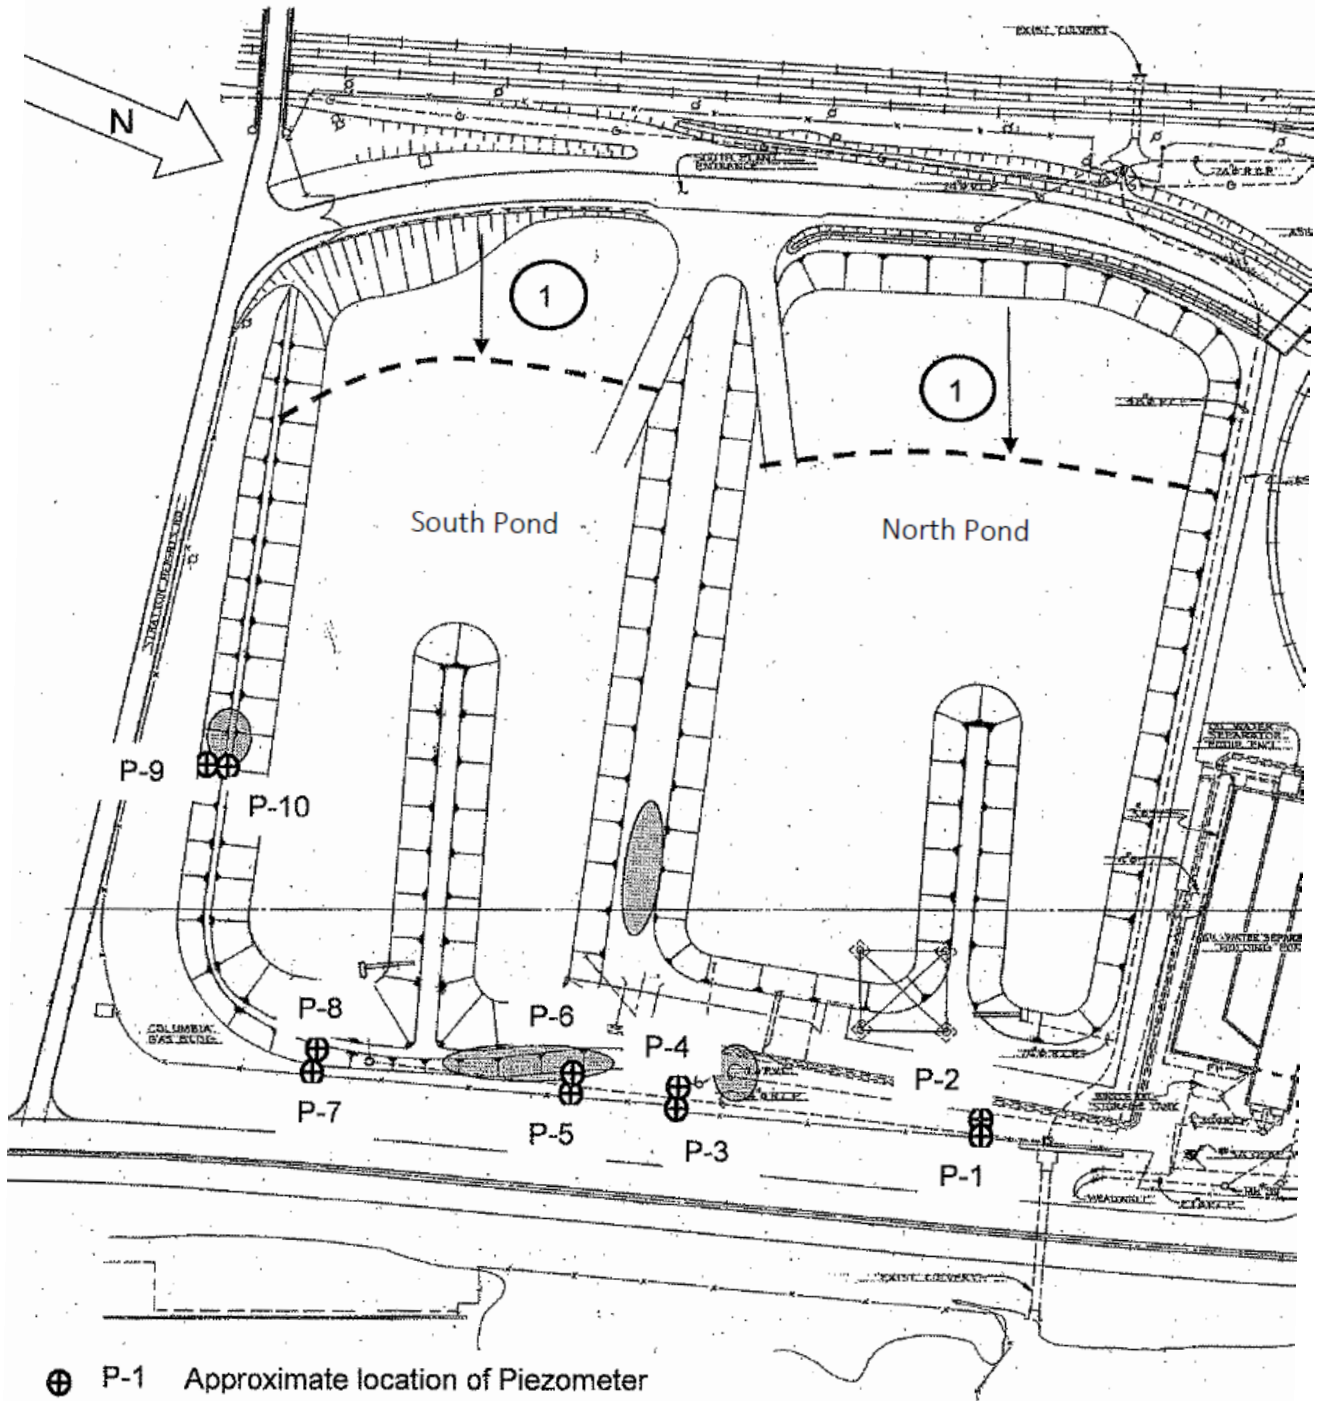
**Piezometer Locations**

Piezometer data is compiled in a Microsoft Excel spreadsheet which was transmitted from FirstEnergy to Geosyntec via email on 1 October 2019. Water elevations in piezometers associated with the North Pond exhibited small variations in water elevation between October 2018 and May 2019, with changes between subsequent readings generally less than 0.5 ft. A decreasing trend in piezometric elevations began in June 2019 and, based on discussions with FirstEnergy staff, corresponds to the time period when the pond was most recently taken out of service. Geosyntec compared piezometric levels with computations prepared for the Periodic Safety Factor Assessment (Geosyntec 2016e). The maximum recorded water levels between October 2018 and September 2019 are approximately equal to or below the piezometric levels previously analyzed and found to represent a stable slope condition.

- Continue to monitor water levels within the piezometers for any increase in elevation above the maximum recorded elevations in 2019. Notify FirstEnergy Engineering if higher water levels are observed.

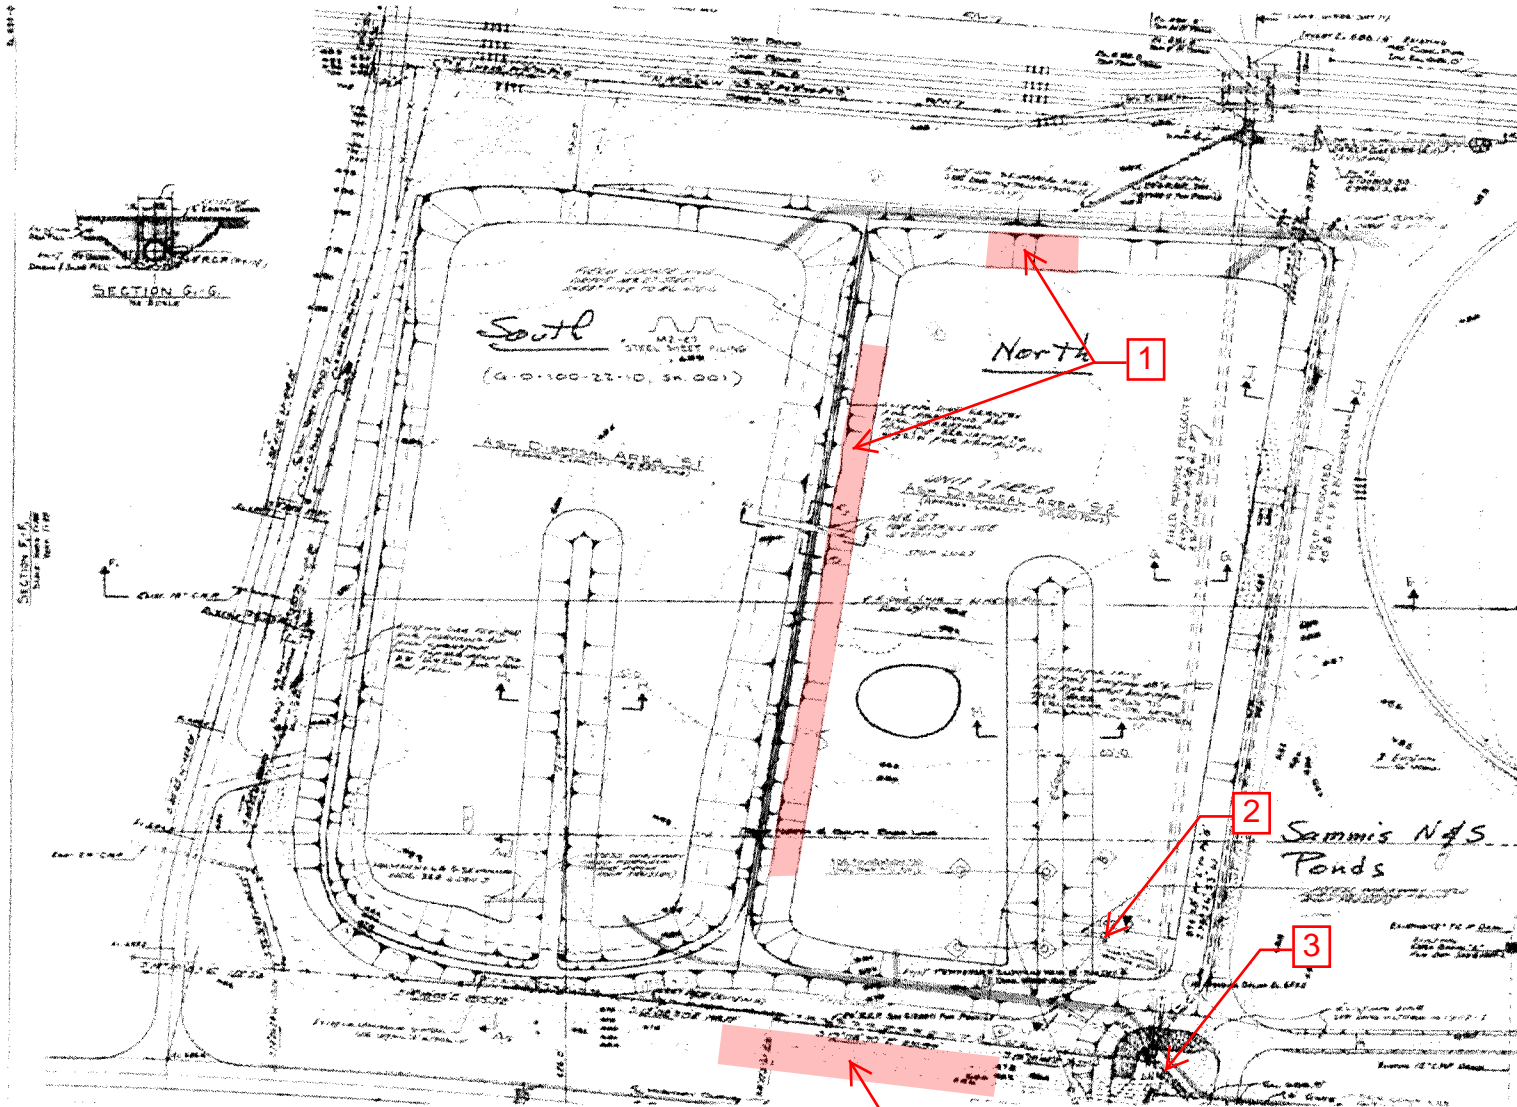
Concrete spalling below high water line.  
Pitting above high water line. Monitor for  
any change in condition. See #2 on map.

At the discharge effluent outlet, inflow from an  
adjacent channel is creating eddy currents. Monitor  
for any change in condition. See #3 on map.

Additional Comments: Larger voids between recycled concrete blocks were filled with brick/concrete/mortar with PVC drainage pipes penetrating the concrete. No signs of seepage or erosion are present at the block wall. Monitor for any change in condition. See #3 on map.

Standing water observed in ditch parallel to toe of eastern embankment. Water appeared clear, and likely from recent precipitation event. See #4 on map.
