2019 ANNUAL INSPECTION REPORT

W.H. Sammis Coal Plant South Pond Stratton, Ohio

CCR Unit: W. H. Sammis South CCR Impoundment

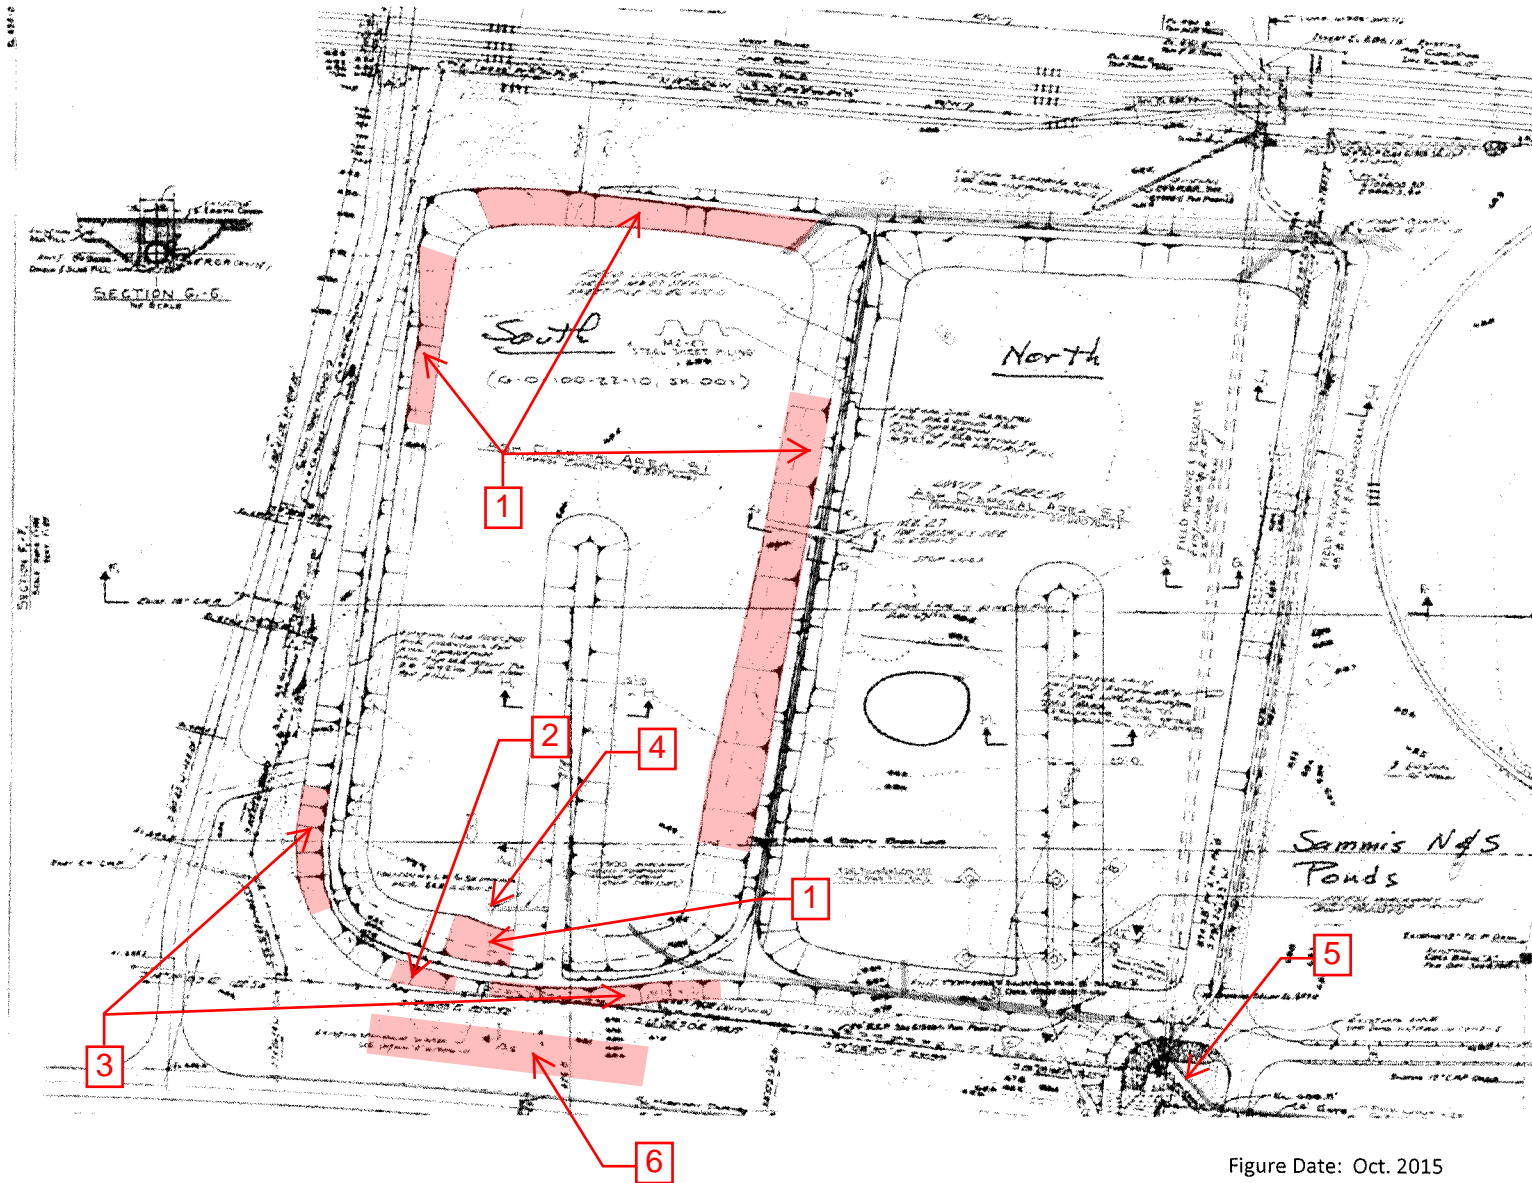
Concrete is spalling/damaged on the exterior upper portion of riser. Condition appears unchanged from previous two years of inspections. Monitor for any change in condition. See #4 on map.

At the discharge effluent outlet, inflow from an adjacent channel is creating eddy currents. Monitor for any change in condition. See #5 on map.

Additional Comments: Larger voids between recycled concrete blocks were filled with brick/concrete/mortar with PVC drainage pipes penetrating the concrete. No signs of seepage or erosion are present at the block wall. Monitor for any change in condition. See #6 on map.

Standing water observed in ditch parallel to toe of eastern embankment. Water appeared clear, and likely from recent precipitation event. See #6 on map. Water level at 10'8" on staff gauge. Less than 25 percent full of ash.
