HOLLOW ROCK FACILITY

2019 ANNUAL LANDFILL INSPECTION REPORT FOR COAL COMBUSTION RESIDUALS (CCR) EXISTING LANDFILL

January 31, 2020

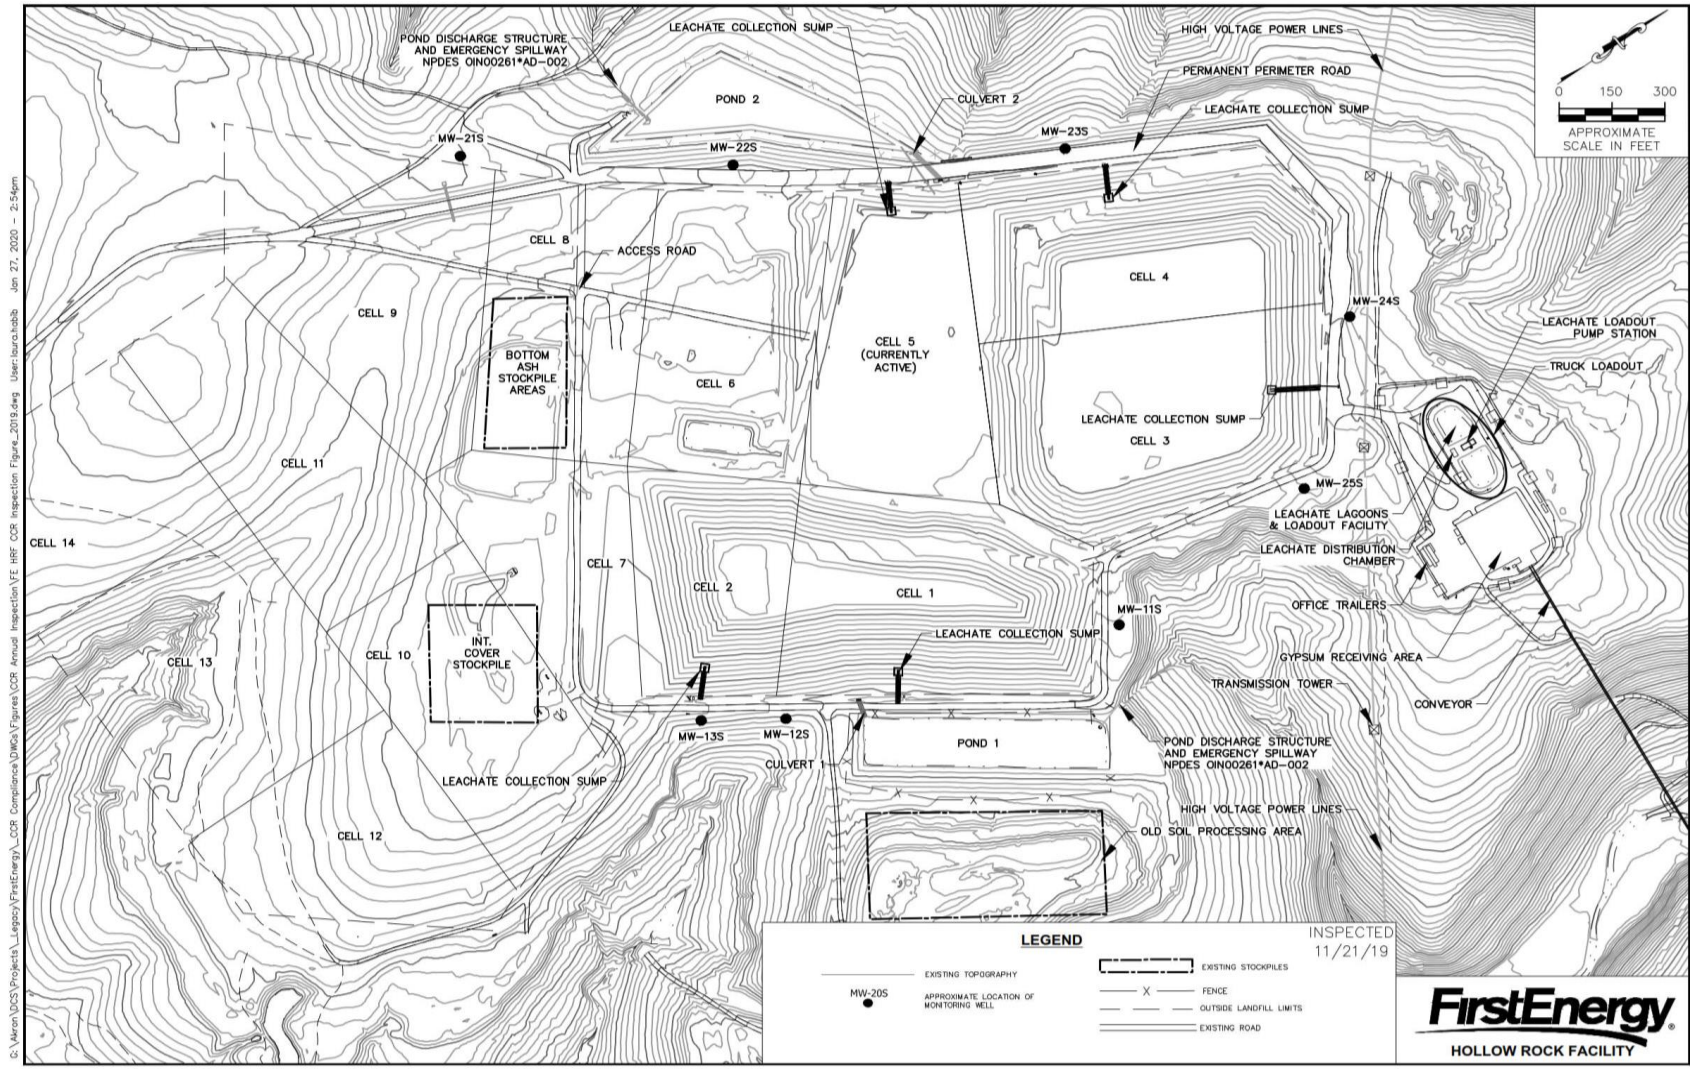
When completed, the overall limit of waste for the HRF will cover a disposal area of 141.6 acres divided into development phases. Currently, Phase 1 (Cells 1 and 2), Phase 2 (Cell 3), Phase 3 (Cell 4), and Phase 4 (Cell 5) have been constructed at the HRF. Cells 1, 2, 3 and 4 have reached the maximum elevation for their respective phases and have received intermediate cover until future adjacent phases will place waste on the interior slopes. FE is currently operating in Cell 5. Figure 1 provides a plan view that shows the location of all the Cells.
