# Former Patterson Avenue Fly Ash Pond Legacy CCR Surface Impoundment Applicability Extension Report

Ohio Edison Company  
Former Gorge Power Station  
Summit County, Ohio

# Former Patterson Avenue Fly Ash Pond Field Investigation Work Plan

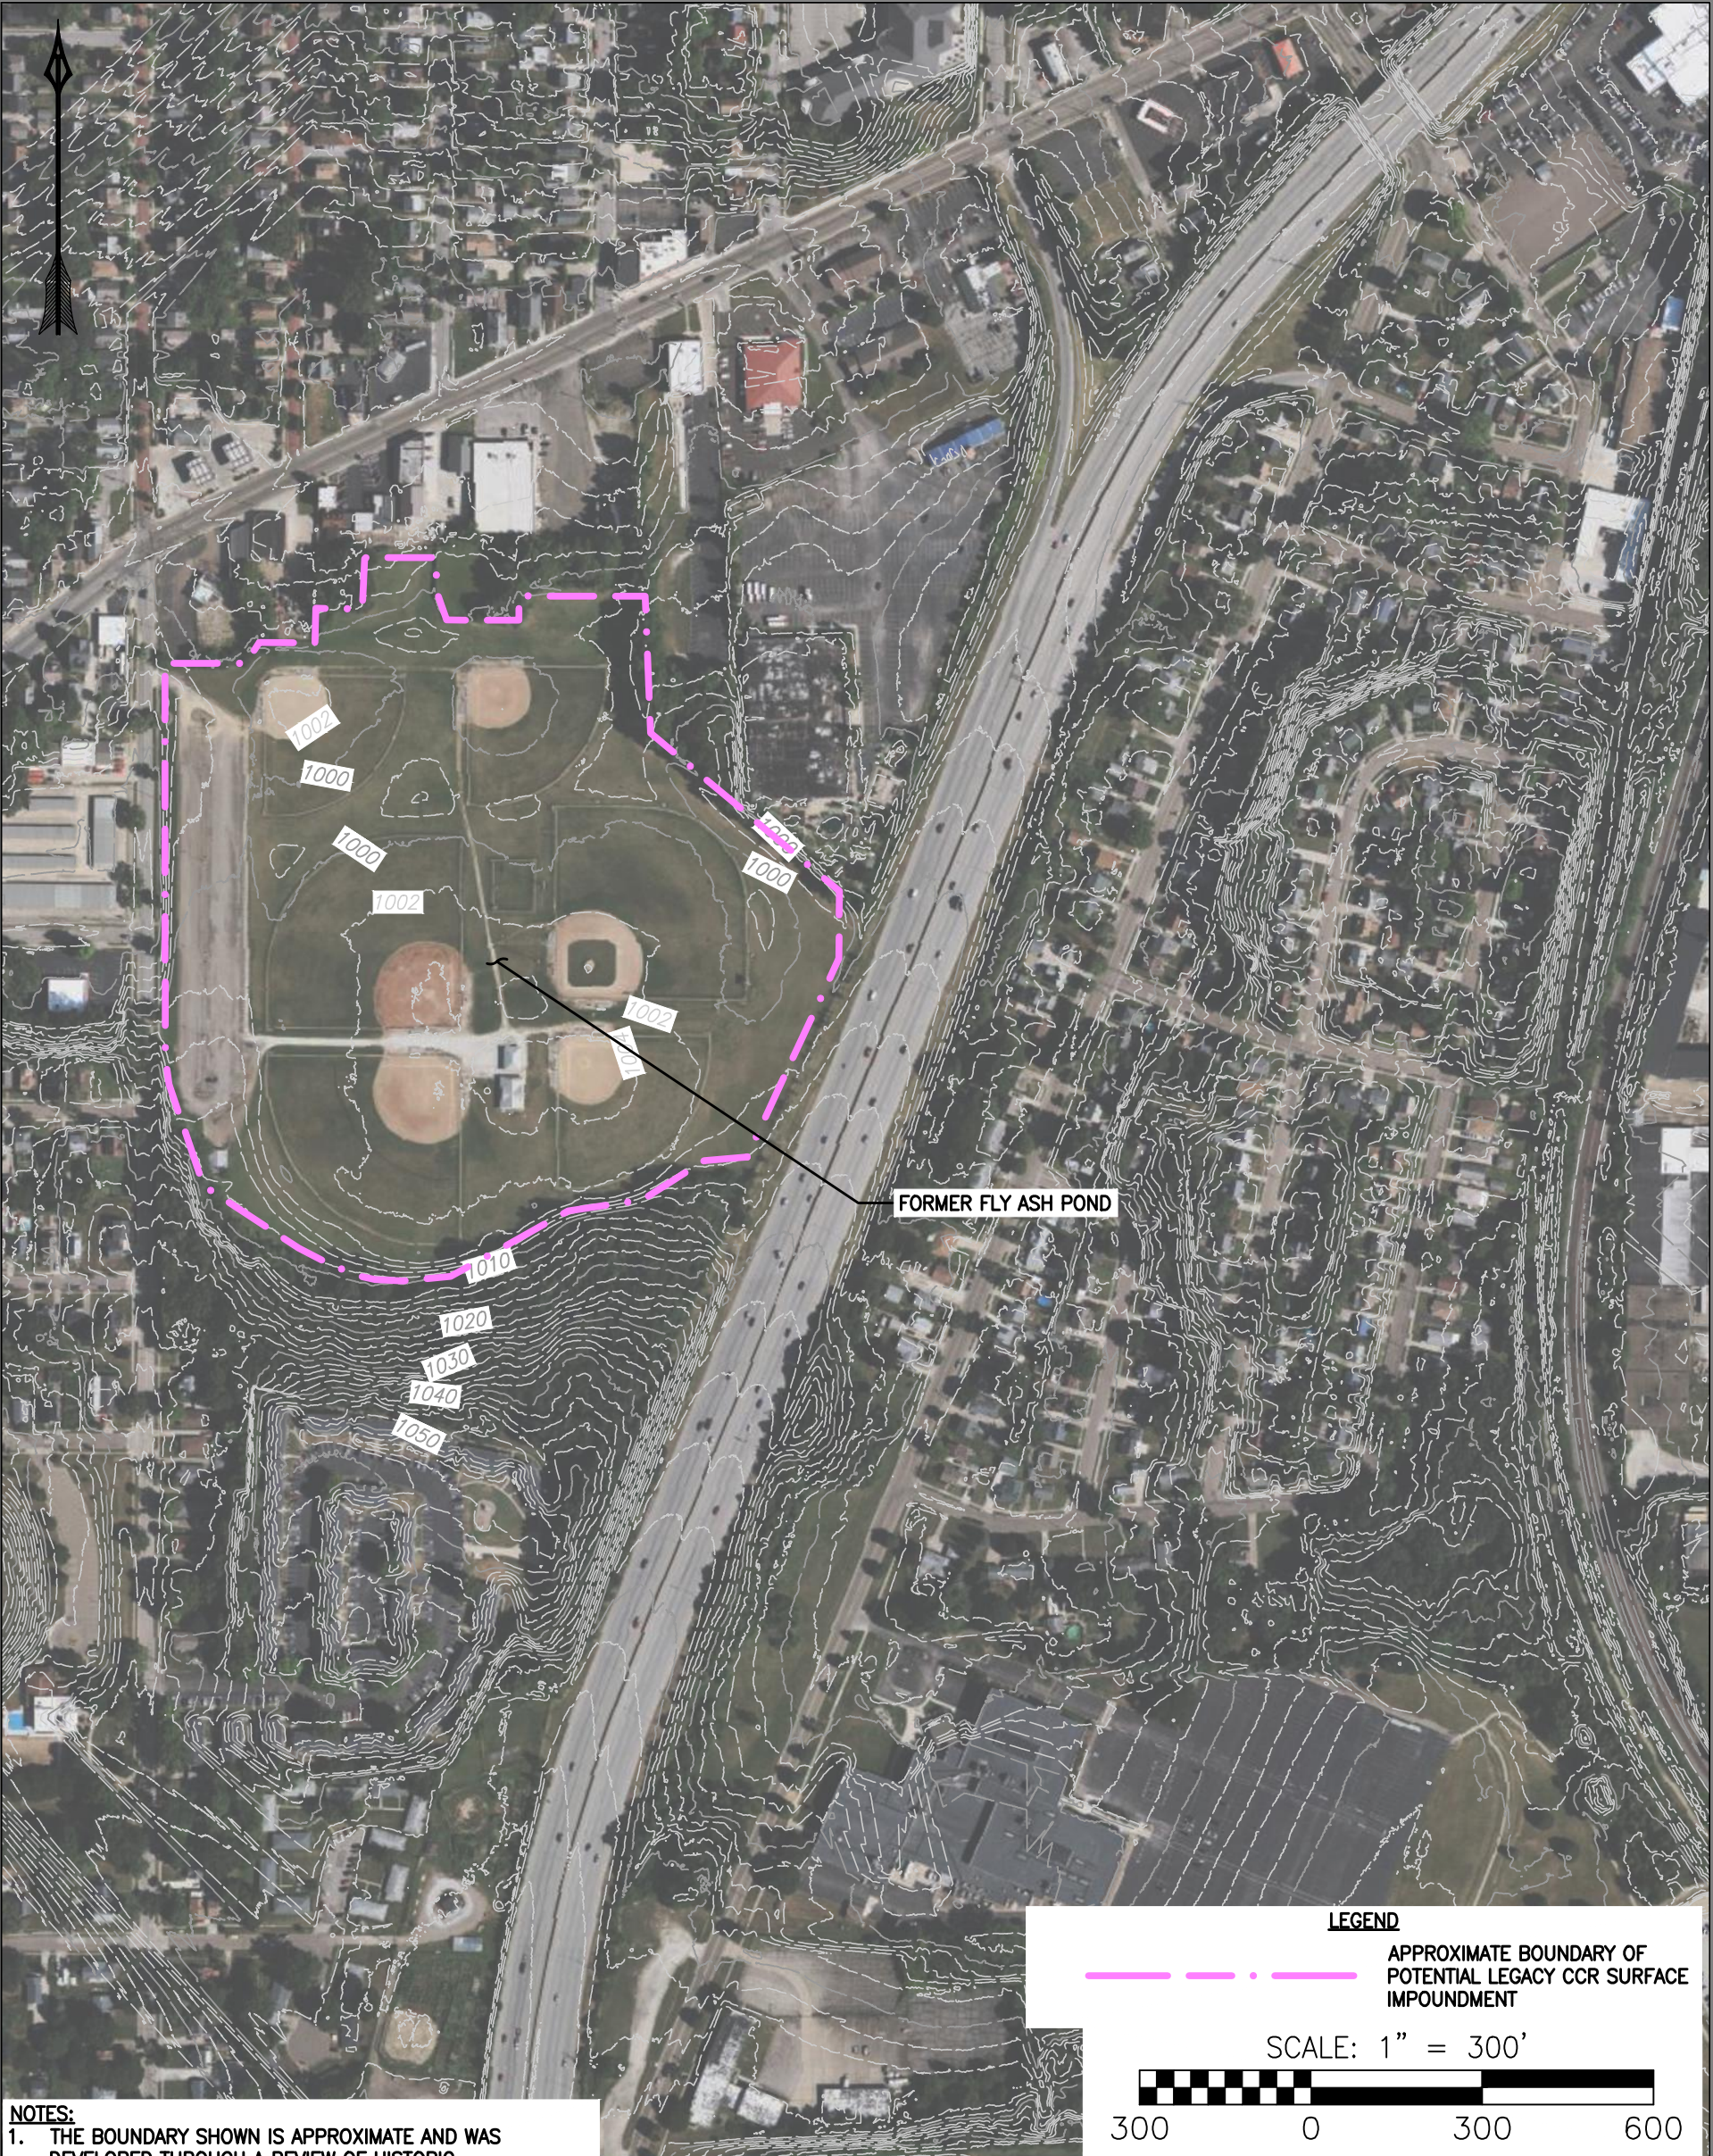
- NOTES:**
1. THE BOUNDARY SHOWN IS APPROXIMATE AND WAS DEVELOPED THROUGH A REVIEW OF HISTORIC DOCUMENTATION.
  2. THE FORMER GORGE POWER STATION WAS LOCATED APPROXIMATELY 0.75 MILES NORTHEAST OF THE DISPOSAL AREA.

| FORMER PATTERSON AVENUE FLY ASH DISPOSAL FACILITY | | | | |

| Regulatory Requirement / Reference | Description |
|---|---|
| <b>Impoundment Identification.</b> Information to identify the legacy CCR surface impoundment, including a figure of the facility and where the unit is located at the facility, facility address, and the latitude and longitude of the facility.<br><i>40 CFR §257.100(f)(1)(i)(C)</i> | The potential legacy CCR impoundment is located at:<br><br>955 Patterson Ave<br>Akron, OH 44310<br>Latitude: 41.110784<br>Longitude: -81.500175<br><br>See the attached Figure GOR001 for a plan view of the facility and former unit. |
